What's Your Plan?

Barrier Removal & Title III Entities: Part 4

May 16, 2014

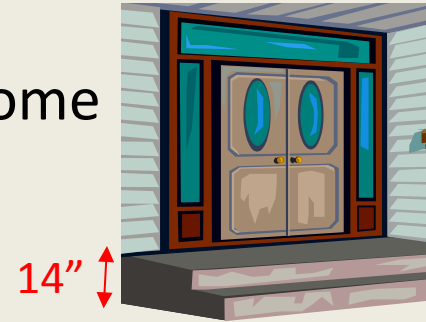
Entrance:

- There are 2 steps to enter the restaurant that overcome an approximately 14 inch rise.
- There are double leaf doors that provide 32 inches of clear width at the entrance. There is no compliant maneuvering clearance on the exterior side of the entrance door. Once inside the restaurant, the “push side” of the door has compliant maneuvering clearance.
- There is sufficient space to install a ramp built at a slope not to exceed 1:12 (approximately 14 feet of ramp is needed at 1:12).
- There is no curb ramp provided to access the sidewalk at the entrance.

DRAFT I Existing Condition	Recommendation	Estimated Completion Date	Estimated Cost
Entrance – US DOJ Priority I			
<p>-There are 2 steps to enter the restaurant that overcome an approximately 14 inch rise.</p> <p>-There is sufficient space to install a ramp built at a slope not to exceed 1:12 (approximately 14 feet of ramp is needed at 1:12).</p>	<p>-Contact architect to gain information on the cost of installing a ramp to overcome the 14 inch rise at the entrance.</p>		<p>Not known yet. Will contact architect to obtain cost estimate.</p>
<p>-There are double leaf doors that provide 32 inches of clear width at the entrance. There is no compliant maneuvering clearance on the exterior side of the entrance door. Once inside the restaurant, the “push side” of the door has compliant maneuvering clearance.</p>	<p>-Ask architect to provide information on how to address the maneuvering clearance at the exterior entrance door(s) when the ramp is added.</p>		<p>Not known yet. Will contact architect to obtain cost estimate.</p>

DRAFT II Existing Condition	Recommendation	Estimated Completion Date	Estimated Cost
Entrance – US DOJ Priority I			
<p>-There are 2 steps to enter the restaurant that overcome a 14 inch rise.</p> <p>-There is sufficient space to install a ramp built at a slope not to exceed 1:12 (approximately 14 feet of ramp is needed at 1:12).</p>	<p>-Architect is going to design a straight run ramp that follows the front of the building at a slope no steeper than 1:12 with compliant landings, handrails and edge protection.</p>	August, 2014	\$3,000
<p>-There are double leaf doors that provide 32 inches of clear width at the entrance. There is no compliant maneuvering clearance on the exterior side of the entrance door. Once inside the restaurant, the “push side” of the door has compliant maneuvering clearance.</p>	<p>-Architect will design the top ramp landing to also serve as an area with compliant door maneuvering clearance on the pull side of the entrance door(s).</p>	August, 2014	Included in cost for ramp above

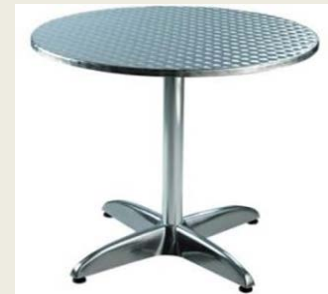
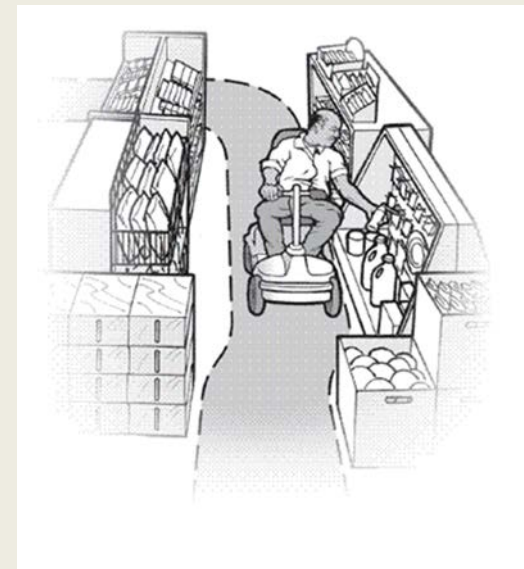
Dining Area

- There are 26 patron seating tables within the diner.
- No accessible tables are provided. The tables provided have pedestal style legs that do not provide compliant knee clearance.
- At the entrance of the diner, there are several racks of merchandise on display. The merchandise and shelving narrow the width of the accessible route to 32 inches for a distance of 4 feet.

DRAFT I Existing Condition	Recommendation	Estimated Completion Date	Estimated Cost
Dining Area – US DOJ Priority II			
<p>-There are 26 patron seating tables within the diner.</p> <p>-No accessible tables are provided. The tables provided have pedestal style legs that do not provide compliant knee clearance.</p>	<p>-Provide 5% of the tables (2 tables) that have compliant knee clearance. Provide at least 30 inches of width between the legs of the table; Provide at least 27 inches of knee clearance underneath the table and the table top height should be between 28 inches and 34 inches above the floor.</p>		\$500
<p>-At the entrance of the diner, there are several racks of merchandise on display. The merchandise and shelving narrow the width of the accessible route to approximately 32 inches for a distance of approximately 4 feet.</p>	<p>-Rearrange the merchandise display area to ensure that a clear width of 36 inches is maintained at the entrance of the diner.</p>		<p>N/A</p> <p>Mr. Smith and Staff will do this work.</p>

DRAFT II Existing Condition	Recommendation	Estimated Completion Date	Estimated Cost
Dining Area – US DOJ Priority II			
<p>-There are 26 patron seating tables within the diner.</p> <p>-No accessible tables are provided. The tables provided have pedestal style legs that do not provide compliant knee clearance.</p>	<p>-Provide 5% of the tables (2 tables) that have compliant knee clearance. Provide at least 30 inches of width between the legs of the table; Provide at least 27 inches of knee clearance underneath the table and the table top height should be between 28 inches and 34 inches above the floor.</p>	October, 2014	\$500
<p>-At the entrance of the diner, there are several racks of merchandise on display. The merchandise and shelving narrow the width of the accessible route to approximately 32 inches for a distance of approximately 4 feet.</p>	<p>-Rearrange the merchandise display area to ensure that a clear width of 36 inches is maintained at the entrance of the diner.</p>	May, 2014	<p>N/A</p> <p>Mr. Smith and Staff will do this work.</p>

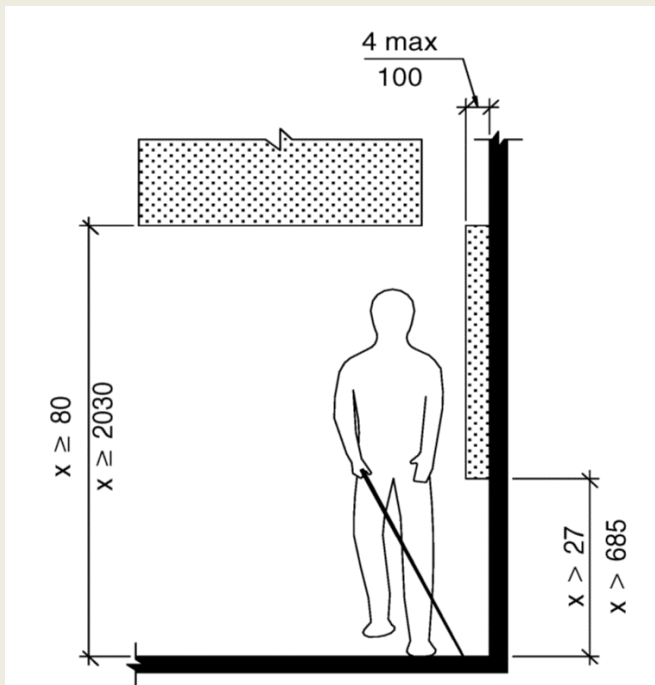
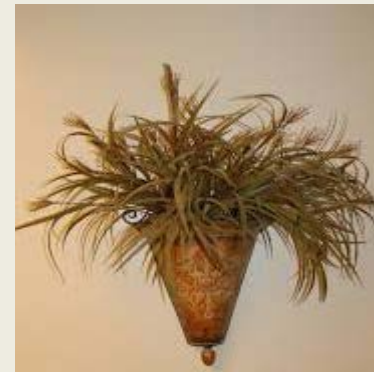
- There are four (4) decorative wall sconces that protrude into the circulation path more than 4 inches with leading edges higher than 27 inches above the floor.

<p>-There are four (4) decorative wall sconces that protrude into the circulation path more than 4 inches with leading edges higher than 27 inches above the floor.</p>	<p>-Remove these decorative wall sconces. If replaced in the future, provide new sconces that do not protrude more than 4 inches into the circulation path.</p>		<p>N/A</p> <p>Mr. Smith and Staff will do this work.</p>

<p>-There are four (4) decorative wall sconces that protrude into the circulation path more than 4 inches with leading edges higher than 27 inches above the floor.</p>	<p>-Remove these decorative wall sconces. If replaced in the future, provide new sconces that do not protrude more than 4 inches into the circulation path.</p>	May, 2014	<p>N/A</p> <p>Mr. Smith and Staff will do this work.</p>
